P91 COMMANDS RESPECT

P91 commands respect

PIPING INSPECTION

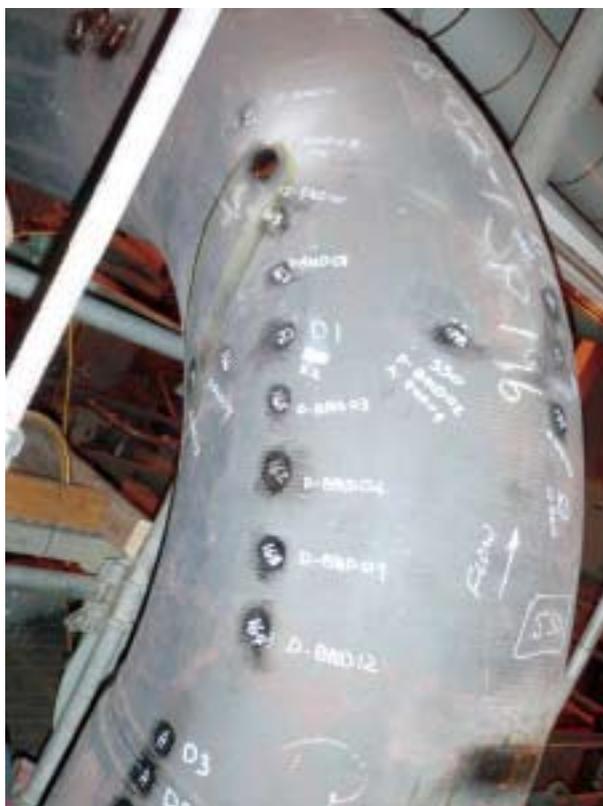
1. Knowing where to take hardness measurements is an art. This 20-in.-diam 90-deg elbow in New Harquahala's HP steam system had "chronic" softness. Several points show hardness readings below 190 HB, the suggested lower limit for P91

Knowing where to take the hardness measurements is an art, Gressler said, and data collection an iterative process. If you find some soft material, he added, you have to go back and take more measurements to see how large the affected area is, and how deep (Fig 1). Sometimes the softness is just at the surface in the decarbur-

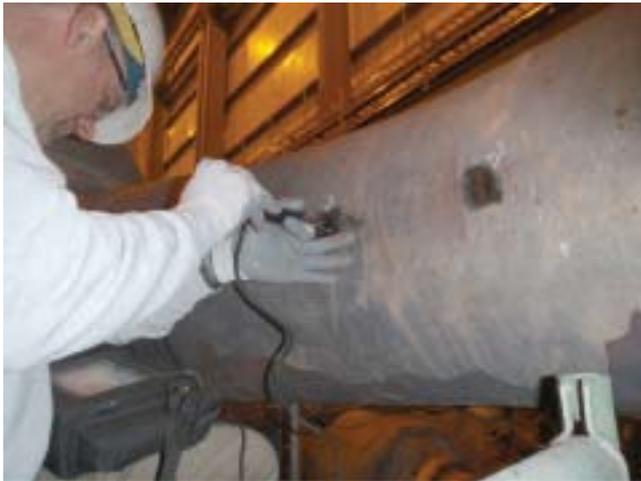
Positive material identification (PMI) and hardness tests were conducted on four HP steam and four HRH components and their respective girth welds. Low hardness values—approximately 170 HB—were found on two 90-deg bends and one tee on the HRH line (Fig 2). These anomalies suggested that in-depth testing was warranted.

2. Technician takes hardness readings on main steam pipe

Metallurgical replicas were taken at representative test points and sent to SI's Material Science Center in Austin, Tex. If analysis confirms

the suspicion of metallurgists that the material has an improper microstructure—and by extension, reduced creep strength—further evaluation will be required.

- Determine the depth of material softening by plug sampling and metallurgical analysis.
- Estimate future serviceability through engineering analysis conducted using conservative material properties in combination with actual design and operating conditions.
- Install high-temperature strain gauges to monitor strain accumulation. This would be done in combination with engineering analysis for life prediction.
- Replace the component.

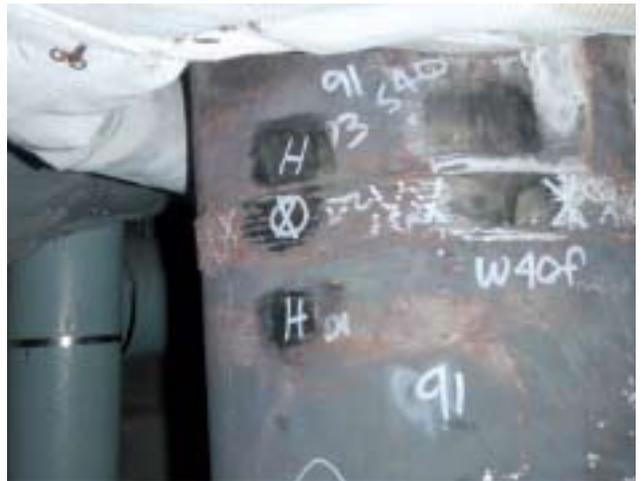
3. Weld joint was found with 1.25Chrome filler material instead of the required 9Chrome

SI's work at New Harquahala uncovered low-alloy filler material in a critical weld in Unit 2's HP steam system (Fig 3). Then metallurgists found the same material in the same weld on both Units 1 and 3. Clearly, this was unexpected and of great concern. You can ask yourself, "Why did this happen? How did this happen?" But you'll probably never know, and the only question that really matters is "How can we correct the situation, and how quickly must we react?"

Background. PMI revealed that the circumferential girth weld joining the P91 transition piece in the main steam line to the P91 steam-turbine stop valve was fabricated using 1.25Chrome material (P91 is 9Chrome). Decision: Replace the weld (Figs 4, 5).

Had the out-of-spec weld not been identified and repaired in a timely manner, failure was highly likely. What often occurs over time when materials of different chromium content are welded together: Cracks initiate and propagate through the carbon-depleted zone that forms during the welding process.

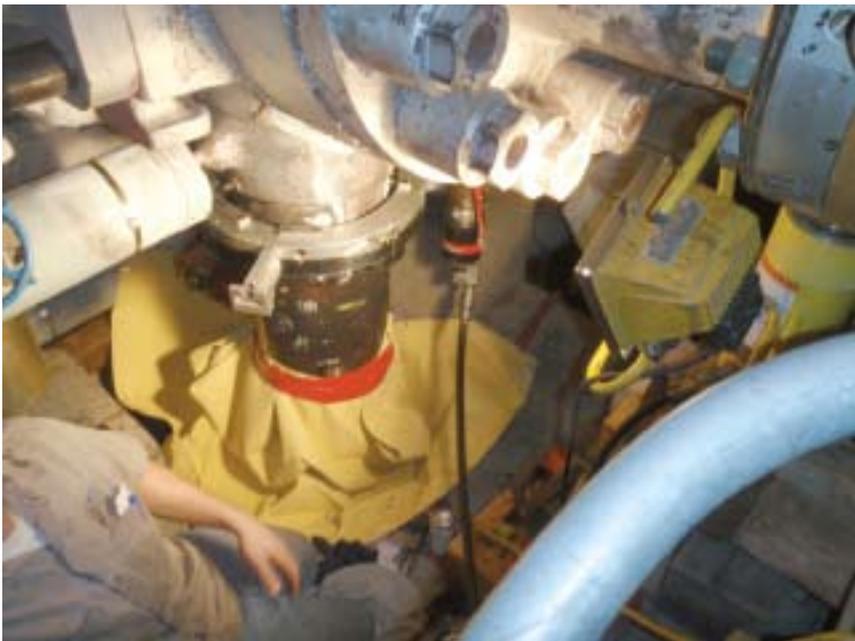
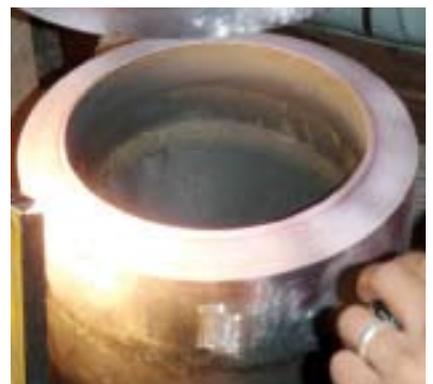
4, 5. Off-spec weld was removed with a clamshell pipe cutter (left) and the joint prepped for rewelding after verifying that no cracks were present in the material (right)

The weld repair was not straight-forward because of the difficult location and the different sources of P91 material for the transition piece and the valve body. Regarding the latter, the valve, fabricated to European code standards, was

SI's position was that the lower PWHT was acceptable but would require a significantly longer time at that temperature than it would at the higher temperature—specifically nine and a half hours at 1346F versus four hours at 1375F. Both the consultant and the plant thought this a reasonable compromise for achieving the required hardness while satisfying the Siemens request.

Hardness tests indicated a successful weld repair. All Brinell values were between 180 and 280 and full transformation to the desired tempered martensitic structure was achieved. More welcome news: There was no damage to the valve. Some softening of the pipe base metal occurred, mostly unavoidable given the extended PWHT soak time.

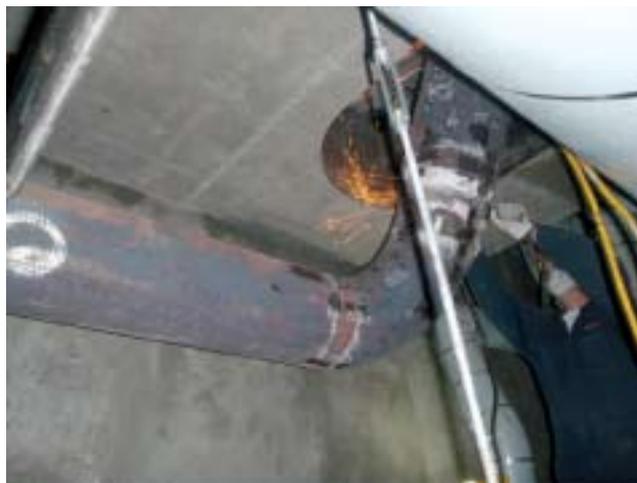
6. P91 pipe is prepped prior to taking hardness measurements

- Prepare locations by grinding only after a hot work permit is in place. A light disk grind of 5 mils or less generally is recommended, followed by use of a flapper wheel 120 grit (Fig 6).
