GRAPHITIZATION

Earlier this year, Structural Integrity performed a comprehensive root cause analysis of catastrophic failures in boiler external primary superheater (PSH) piping (Figure 1). Ultimately, it was positively determined that a previously undocumented form of graphitization was responsible for the failures. Further investigation to establish the extent of the problem found similar degradation in more than one operating unit.

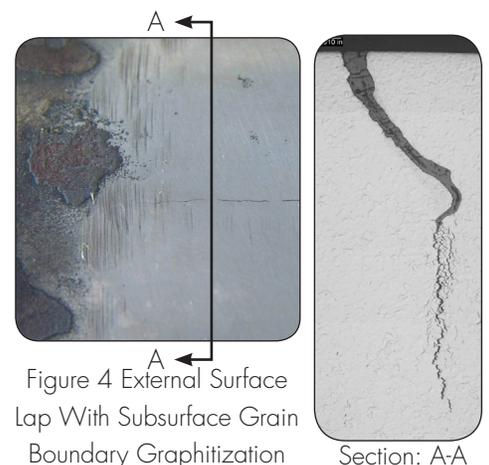
Even though P1 material is known to graphitize after prolonged exposures to elevated temperatures, the morphology of the graphitization in the piping bends was unique and to this point undocumented. Specifically, the damage was generally planar, was located entirely within the grain boundaries, and was widely distributed volumetrically throughout the base metal, as shown in Figure 2. This planar form is significantly different from the previously documented forms of graphitization that occur in either the base metal or weld heat affected zones, specifically the nodular or chain-type morphologies, as shown in Figure 3. The examination of the primary superheater piping also showed that the grain boundary graphitization can form subsurface at stress-raising notches such as common fabrication defects like surface laps, as shown in Figure 4.

Figure 4 External Surface Lap With Subsurface Grain Boundary Graphitization

In light of this most recent failure it is clear that a re-thinking of approach is in order for the detection of volumetric degradation associated with this newly identified form of graphitization in P1 material. Structural Integrity recommends that owner/operators re-evaluate their condition assessment and asset management programs to ensure that the potential for this damage is addressed. Plant records should be reviewed to determine the presence of P1 steel piping and the operating conditions under which such material has been in service.
