Great River Energy -
Coal Creek Station

Evaluation of Circumferential Cracking in a Sub-Critical Coal Fired Boiler Waterwall Tubing- Great River Energy Project

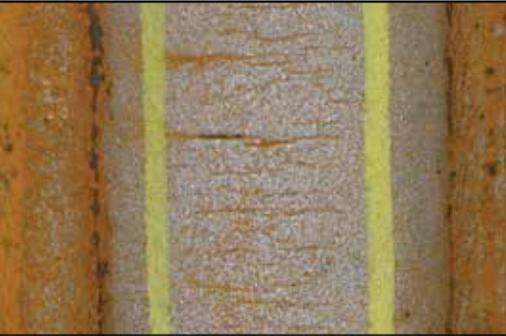
Close-up of
Circumferential Cracking

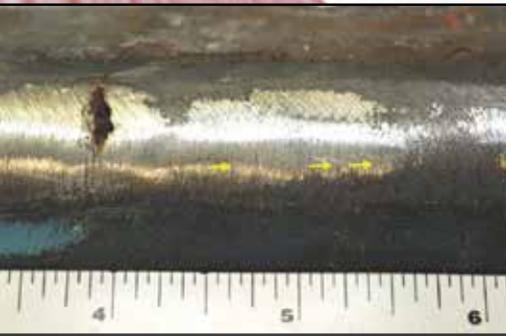
Leak

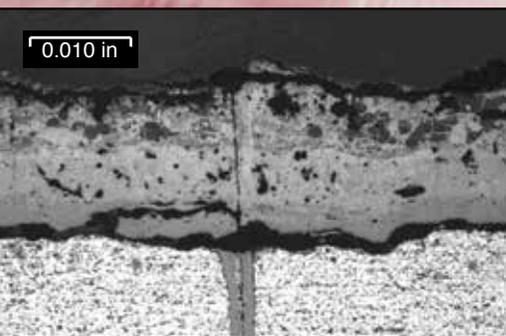
Typical Crack Morphology
