# NEWS & VIEWS

## Advanced NDE for Hydroelectric Penstock Inspection pg. 16

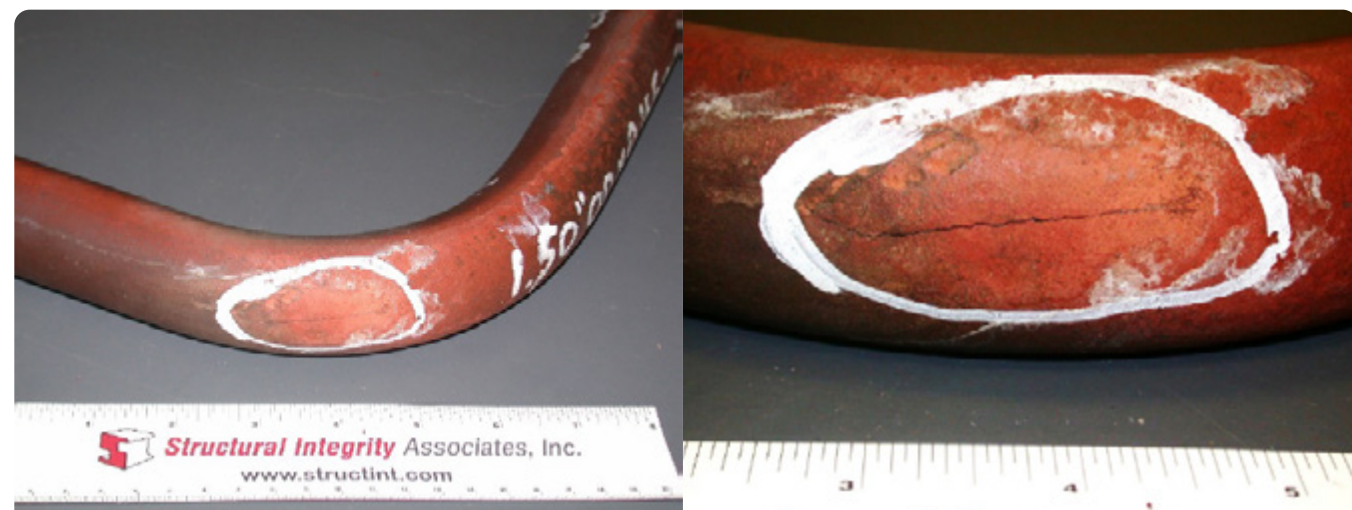
Longitudinally oriented crack at the extrados of a bend in a stainless steel superheater tube.

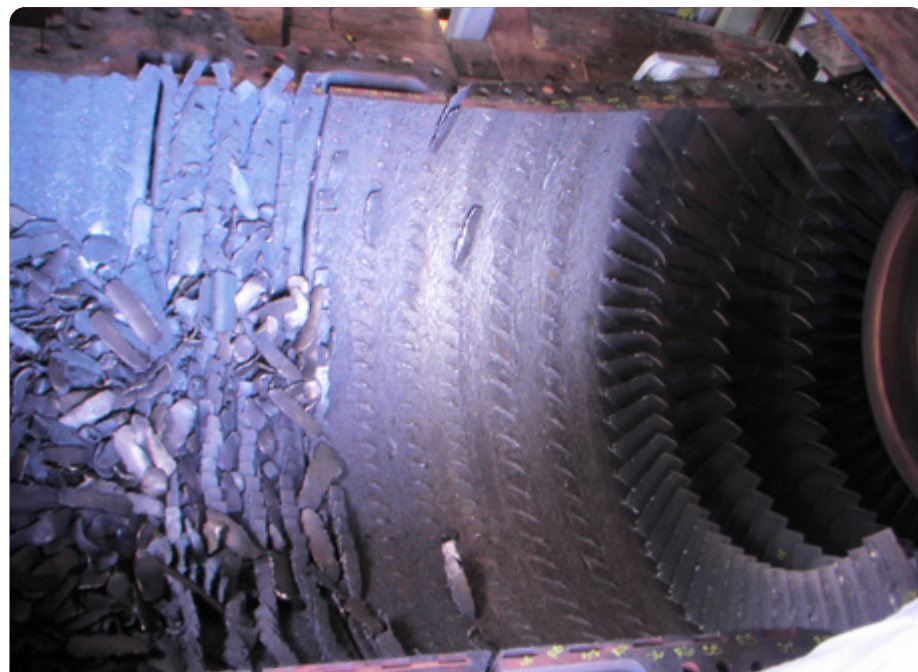
FIGURE 1. Lower compressor casing after large forward blade liberation, causing a forced outage and catastrophic damage to aft components.

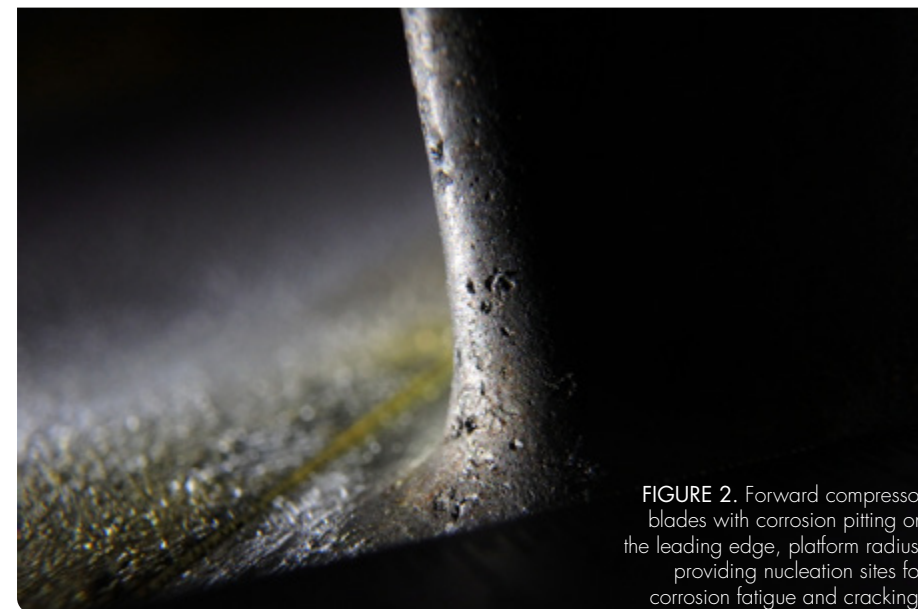
FIGURE 2. Forward compressor blades with corrosion pitting on the leading edge, platform radius, providing nucleation sites for corrosion fatigue and cracking.

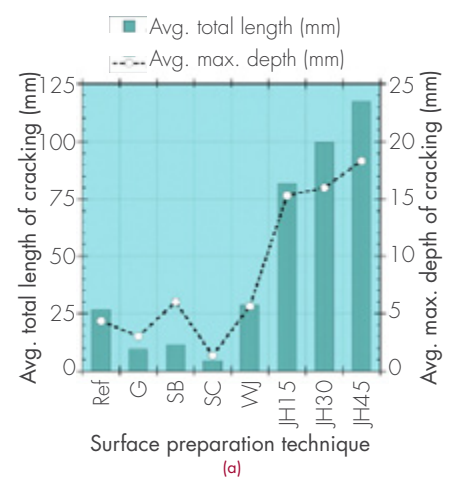
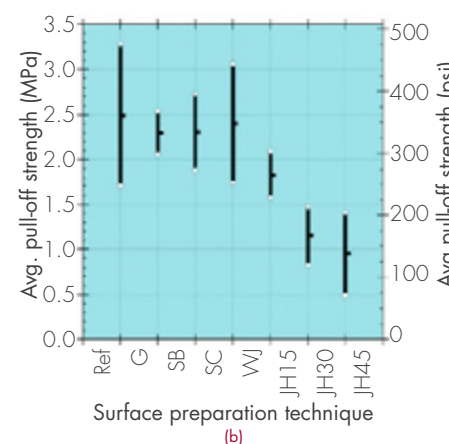
FIGURE 1 – (a) Average crack length and depth and (b) average pull-off strength by surface preparation technique from ACI PRC-364.7-21.

The results from the third-party review revealed that the poor bond strength (Figure 1b) was caused by the excavation method. Microcracking at this level is consistent with excavation from a 15-lb impact hammer (Figure 1a) which was specified for the assessment. This result led SI and DE to believe microcracking was the primary cause rather than the carbonation.

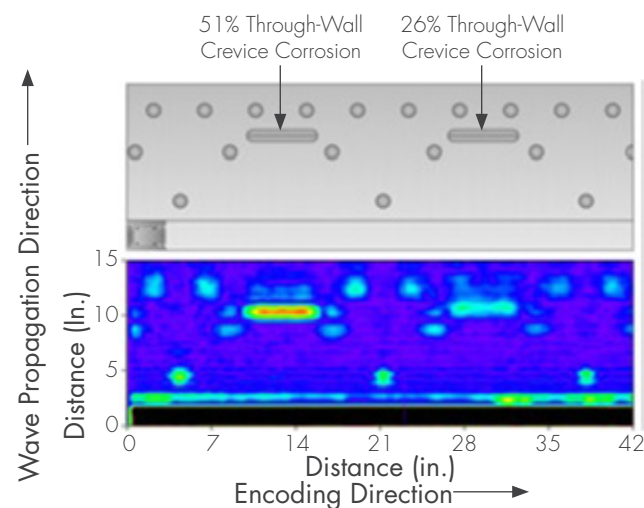
FIGURE 4. Mock-up drawing and actual examination data from SR-GWT test.

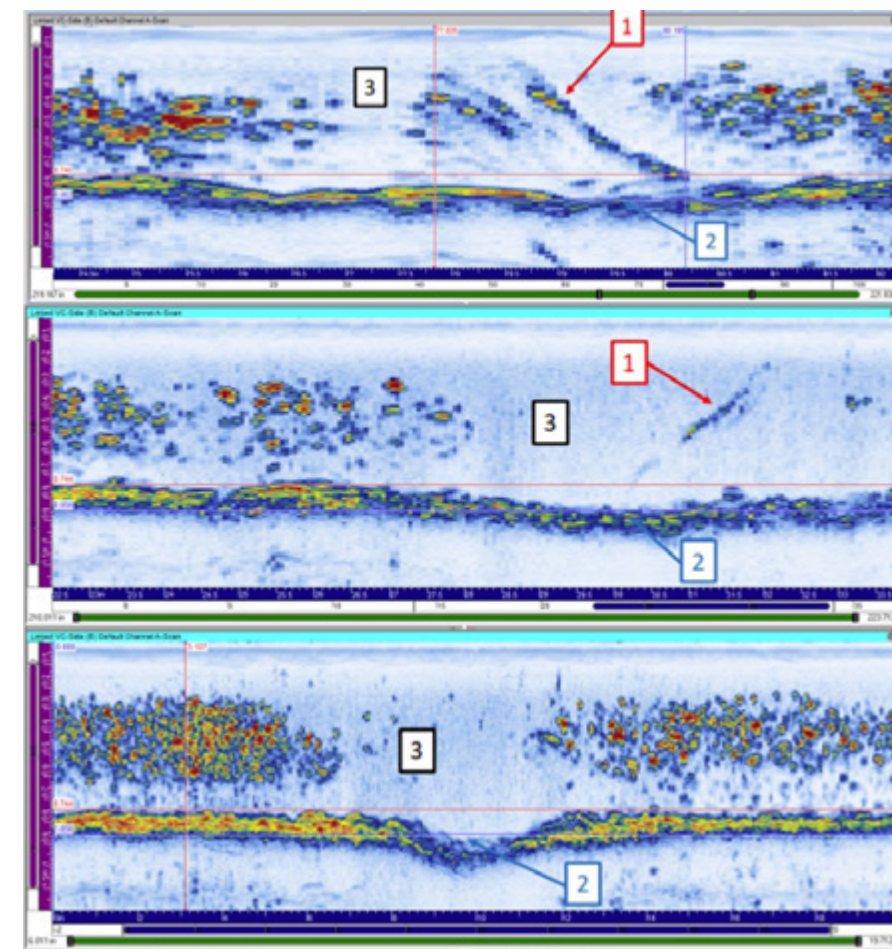
FIGURE 6. PAUT scans at 0° incidence (image is analogous to a cross-section of the weld) from hammer-welded pipe showing seam indications (labelled "1") increased wall thickness at the seam (labelled "2"), and relatively clean areas adjacent to the seam (labelled "3"). The top image and center images show indications from the bond line (likely indicating lack-of-fusion), while the bottom image shows no indications from the bond line. Note that the base material on the left and right ends of the image shows dense areas of small indications, likely attributable to numerous impurities and inclusions in low-quality skelp from which this pipe was manufactured.

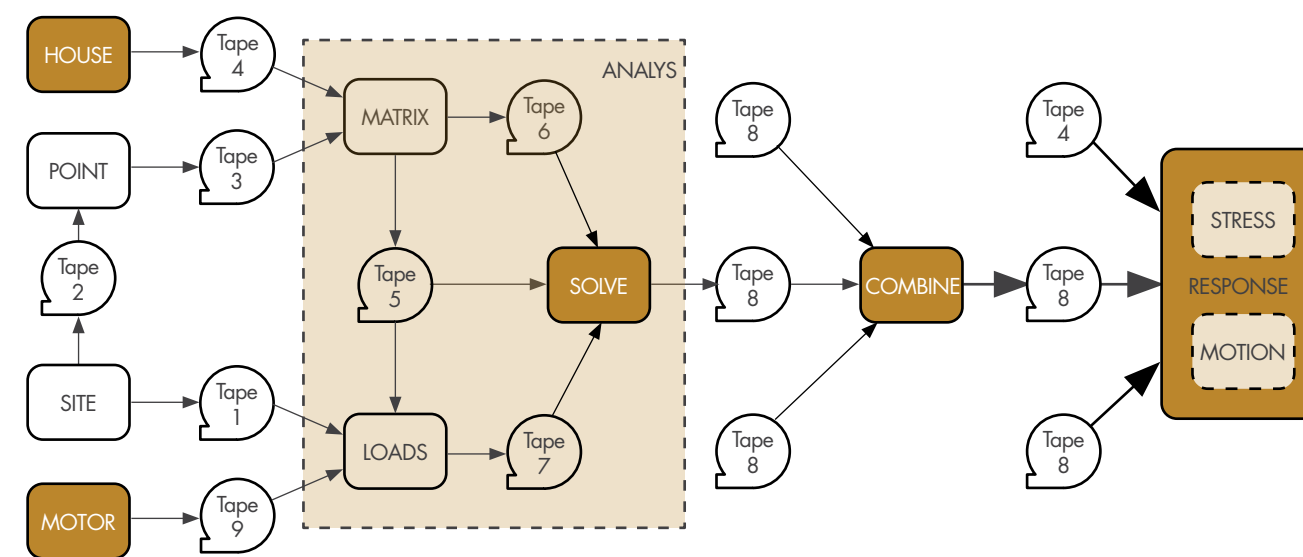
FIGURE 1. Key SC-SASSI Improvements (Shown in Gold) to Traditional SASSI Modules.

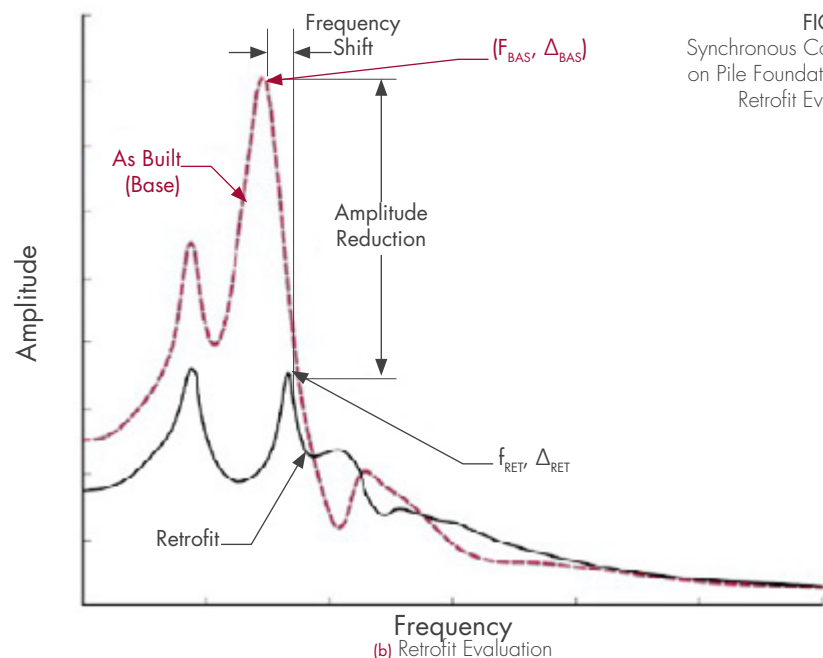
FIGURE 4. Synchronous Condenser on Pile Foundations and Retrofit Evaluation.

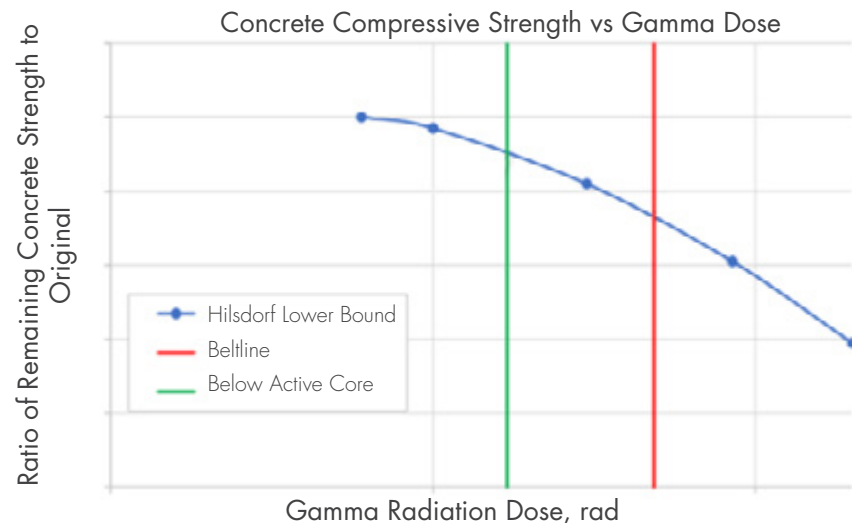
FIGURE 2. Typical Reduction in concrete strength due to irradiation.

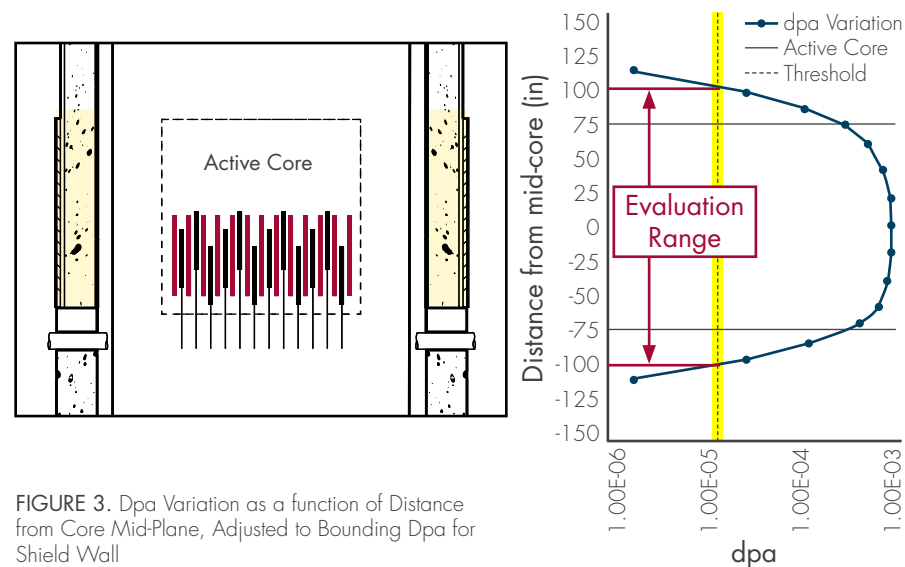
FIGURE 3. Dpa Variation as a function of Distance from Core Mid-Plane, Adjusted to Bounding Dpa for Shield Wall

For the indicated region, the effect of irradiation on the shift in ductile to brittle fracture transition temperature (known as “nil ductility temperature” or NDT) was evaluated. An NDT shift is calculated by referencing the irradiation at various elevations against criteria from NUREG-1509; this value is added to the initial NDT to compute an adjusted NDT.

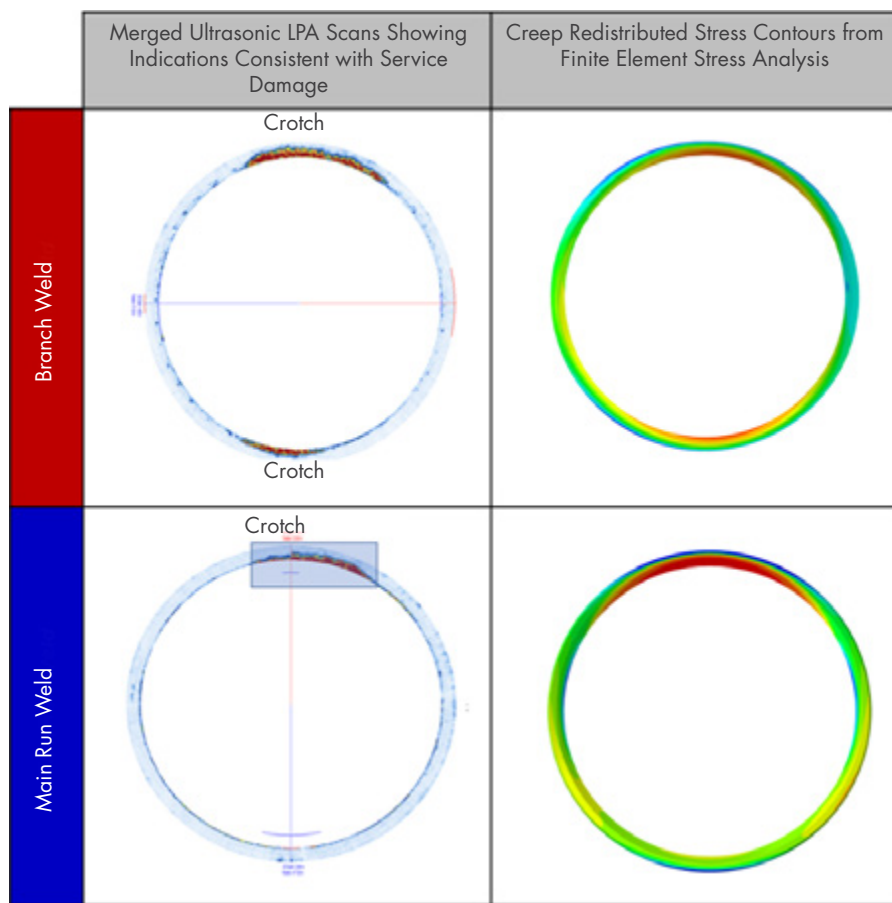
FIGURE 2. Examples of Phased Array Ultrasonic Scans with Indications and Finite Element Color Contour Stress Distribution.

Stresses from piping deadweight and thermal expansion may play a role in biasing damage towards a certain location. However, finite element analyses, ultrasonic inspections of in-service tees, and metallurgical evaluations of cross-sections from ex-service tees have all validated that the distribution of creep damage is consistent with the stress distribution from internal pressure stresses. Figure 2 shows two example ultrasonic phased array scans (left) depicting subsurface indications that are consistent with the creep redistributed FEA stress distribution (right).
