# TURBINE & GENERATOR SERVICES ADVANCED NDE AND ENGINEERING ASSESSMENTS

Siemens 13.9m<sup>2</sup> LP Rotors

## SI provides Comprehensive NDE and Engineering Assessments for Siemens 13.9m<sup>2</sup> LP Rotors

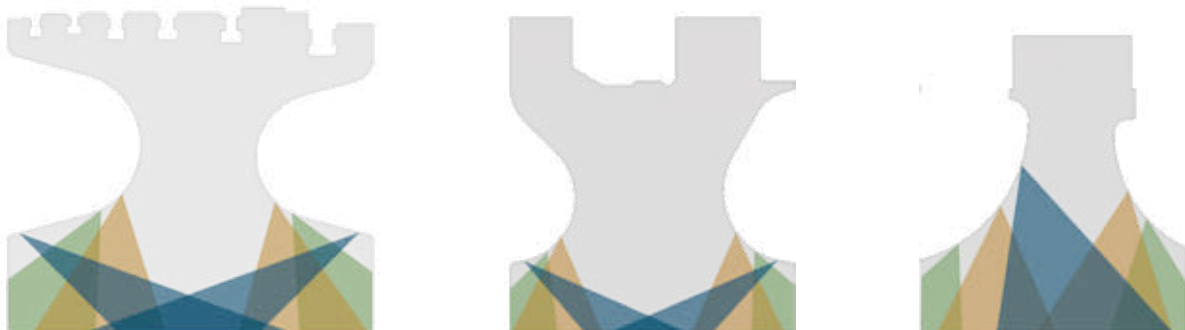
## Newly Redeveloped PAUT Technique Provides 100% Disk Bore Coverage with Overlap/Redundancy in High-Stress Regions

- Primary probe provides larger near field increased coverage & reduced risk of signal attenuation losses.
- Scan plan includes 17 probe locations with 51 scans per flow, 102 scans per rotor.
- Overall sectoral angles allow for scan redundancy/overlap of critical regions.
- Contingencies in place to address attenuation and geometric variation risks.

\*Grit blasting of flow pass surfaces and all disks required for comprehensive inspection. Partial in-situ inspection available as an option.

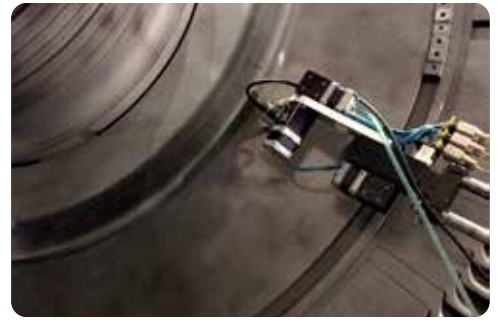
## SHRUNK-ON DISK BORE KEYWAYS

Shrunk-on disk bores/keyways are susceptible to stress corrosion cracking (SCC) due to the high stresses of the shrink-fit and potentially poor water/steam chemistry. SI's re-developed phased array examination protocol provides 100% coverage of the bore region on all wheels and keyways, with overlap redundancy.

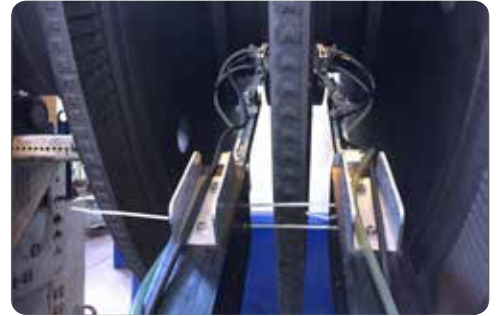
## BLADE ATTACHMENTS

Our EPRI-demonstrated process makes use of linear phased array technology to analyze the rotor wheel blade attachments (dovetails). This inspection focuses on the detection and subsequent sizing of cracks within the blade attachments. By trending crack growth and performing a fracture mechanics analysis, SI can provide the critical information needed for owners to successfully manage the run/repair/replacement decision process concerning these rotors.

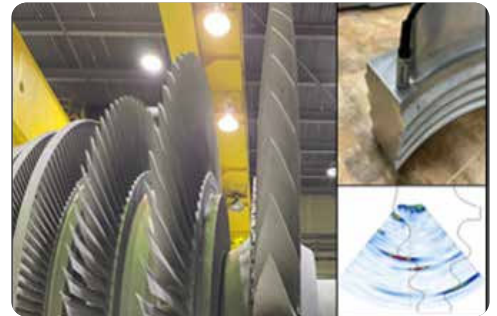
## BLADE ROOTS

Due to the large blade size and rotation speeds of the Siemens 13.9m2, the L-0 curved, axially mounted blade roots are subjected to high centrifugal forces. These forces often leave the blade root susceptible to low cycle fatigue (LCF), high cycle fatigue (HCF), stress corrosion cracking (SCC) and result in blade root cracking. SI performs a proven manual phased array examination of each blade root to detect and size blade root cracking.

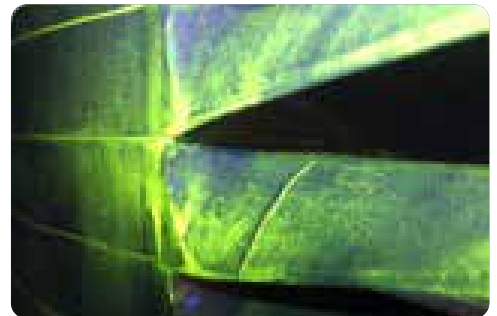
## WET FLUORESCENT MAGNETIC PARTICLE TESTING (WFMT)

SI provides a complete assessment of the rotor surfaces via a thorough visual and WFMT inspection of all accessible surfaces. A portable high amperage magnetic testing (MT) machine and multi-turn cables provide the flexibility to do in-situ inspections and provide rapid results.
